HERITAGE IMPACT ASSESSMENT

PROPOSED STRATEGIC HOUSING DEVELOPMENT

“DE LA SALLE” SCHOOL AND MONASTERY,
BALLYFERMOT, DUBLIN 10.

DERMOT NOLAN
CONSERVATION ARCHITECT

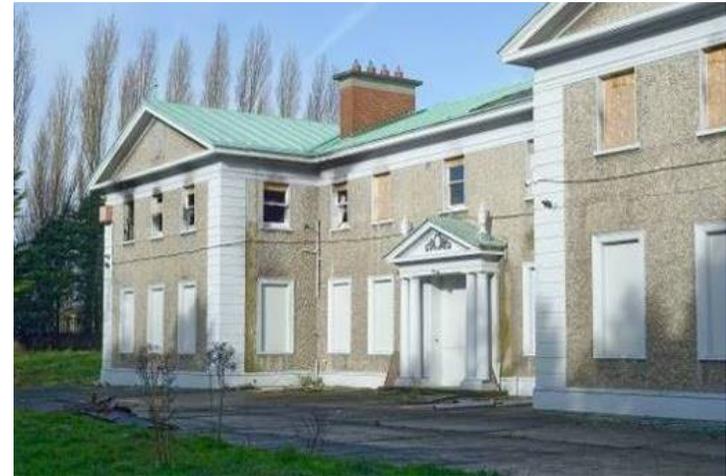
PIC. 10; FRONT OF MONASTERY BUILDING.

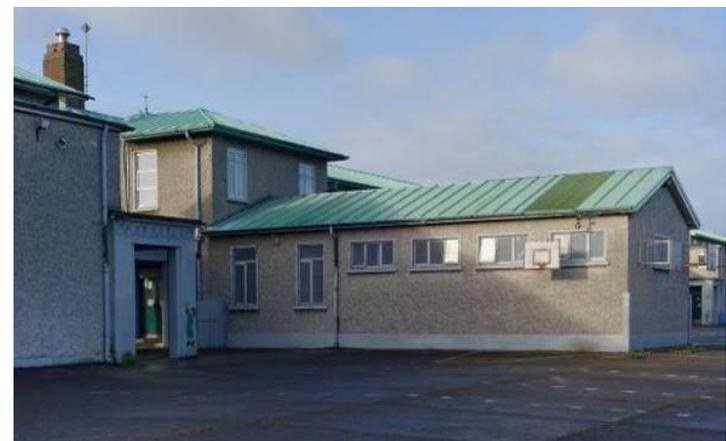
PIC. 11; TOILET BLOCK (NOTE PATCHING TO ROOF).

In fact, it is thought that the retention of the toilet block is harmful to the character of the main building, as is demonstrated at PICS 11 and 12.

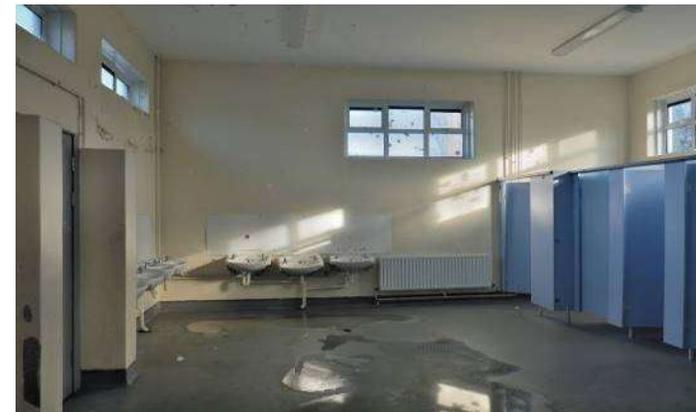
4.12 It is thought that the inclusion of the toilet block in the RPS is not warranted.

PIC 16; INTERIOR OF TOILET BLOCK.

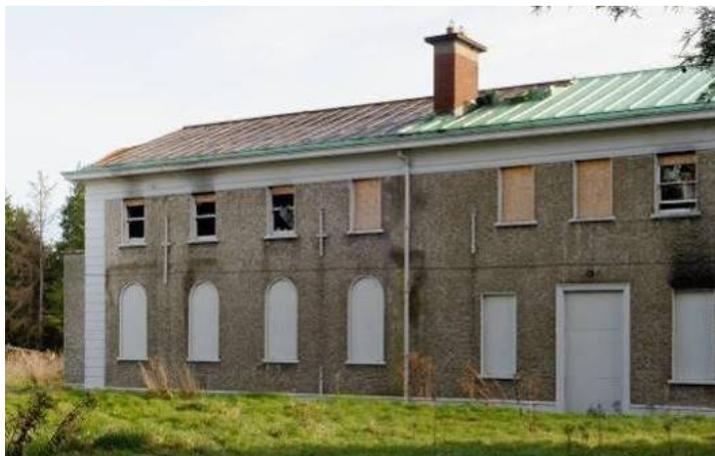
The monastery however has been vandalised, and is regarded as in generally poor condition, with the following matters noted in the sub-sections below.

PIC. 17; GENERAL VIEW OF MONASTERY BUILDING.

5.1.1 The pitched roof covering & fitting were examined from ground level only. Copper has been removed from the roof of the monastery building, allowing water ingress for some time.

5.1.2 It seemed that the monastery has been subject to arson attack. It is not fully known to what extent damage has been caused by fire damage.

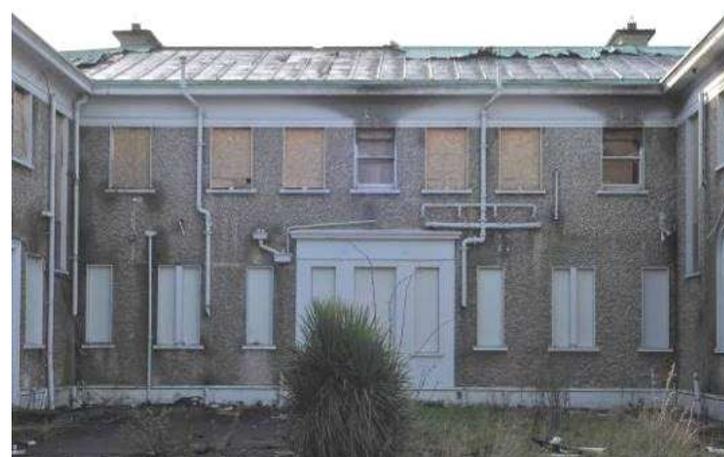
PIC. 18; MONASTERY. NOTE VANDALISM TO ROOF.

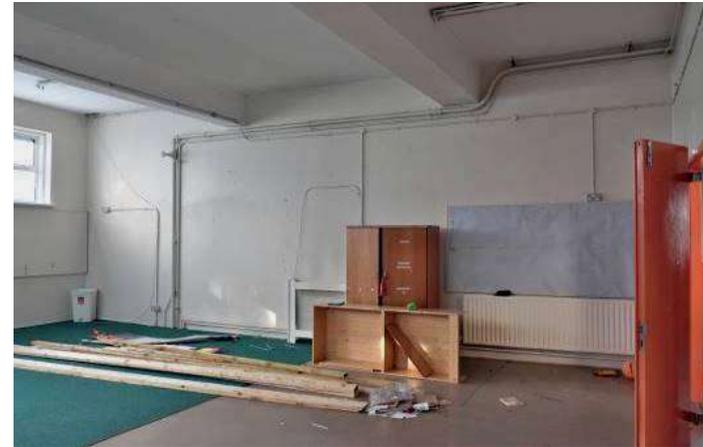
PIC 21; CLASSROOM, WITH WORK ONGOING.

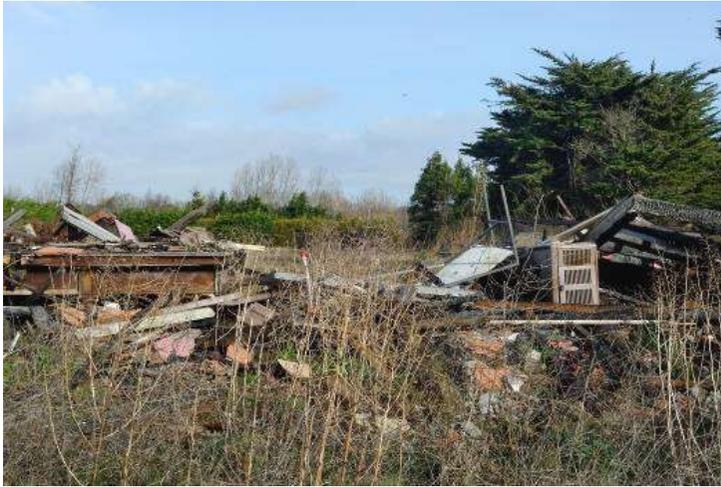
These also apparently have suffered from vandalism; they have thus been demolished, with their debris remaining on site.

PIC 22; TOTAL DERELICTION OF OUTBUILDINGS (REMAINS INDICATED).

5.5.2 These are thought to have been of inferior construction, based on observation of their remnants.
